A REVIEW OF MOSQUITO CONTROL OPERATIONS
IN MASSACHUSETTS WETLANDS

REGULATORY BRANCH, NEW ENGLAND DIVISION
U.S. ARMY CORPS OF ENGINEERS

Robert J. DeSista
Charles J. Newling
1979

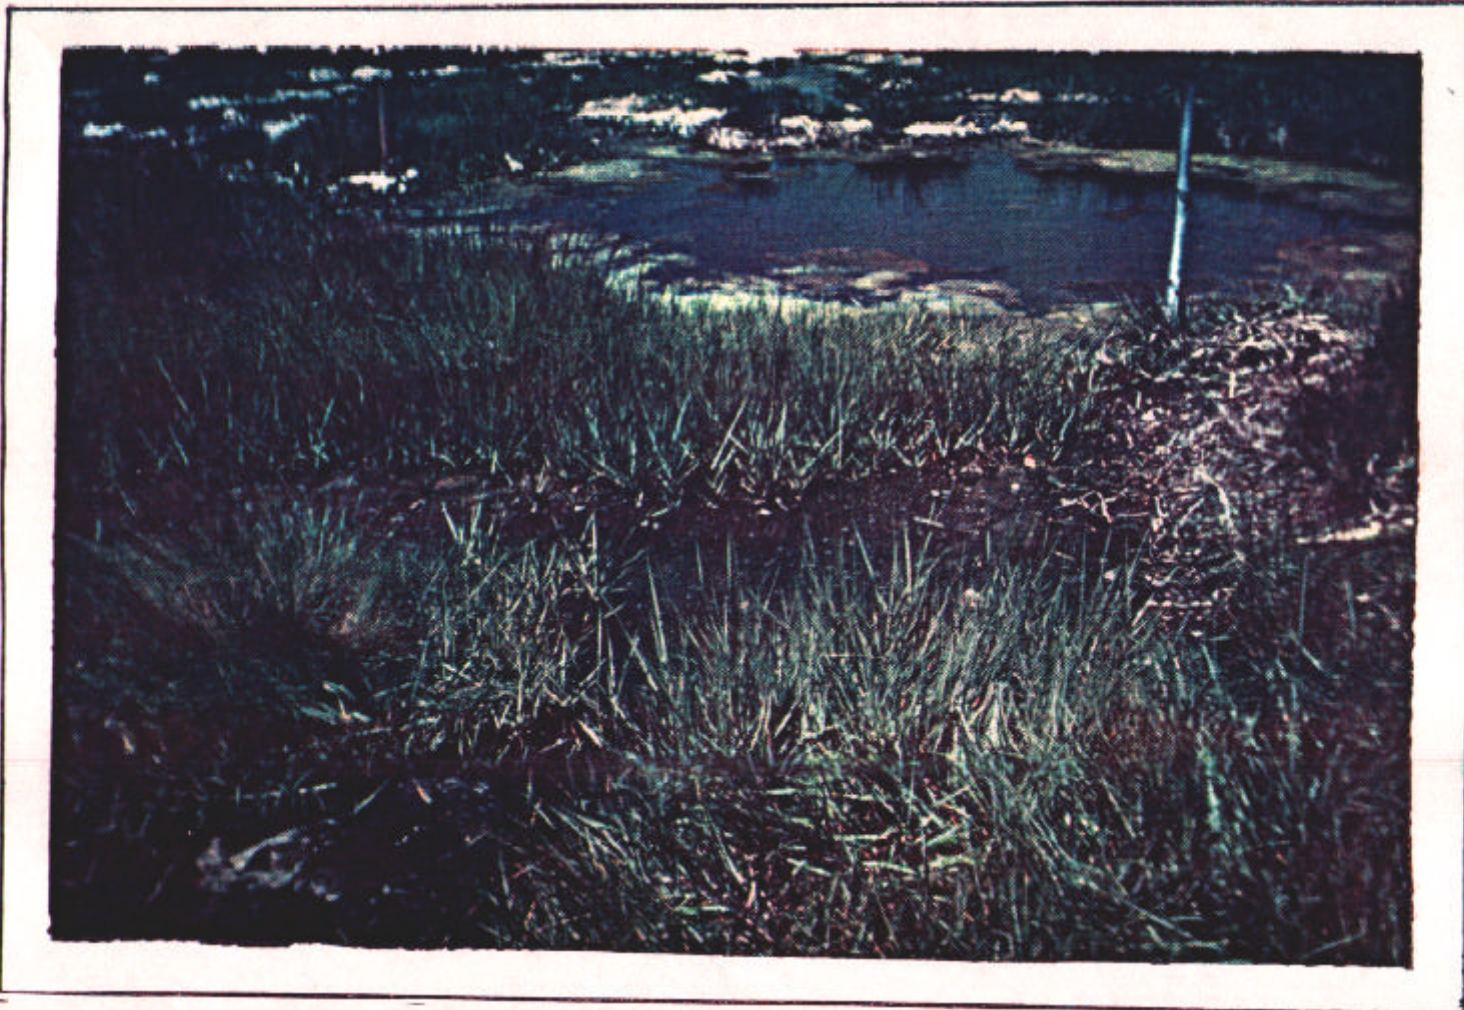
(Fig. 2) Non-breeding pond (Background) with sufficient depth to support a fish population. A breeding pond is in the foreground. (Rowley, Mass. 28 June 1978).

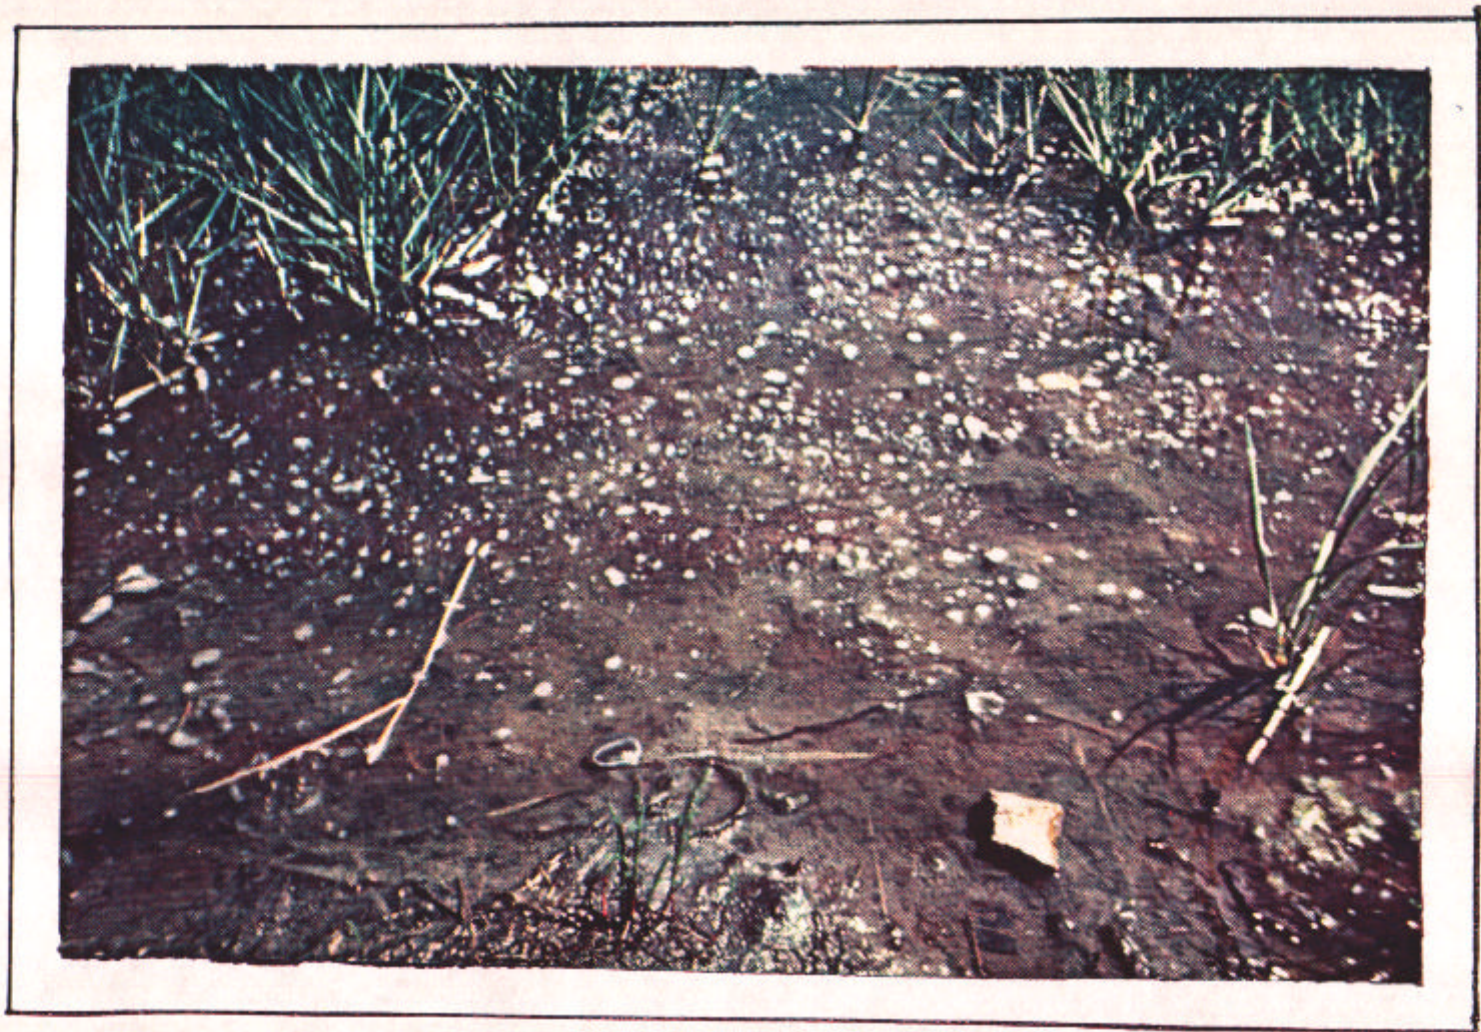
(Fig. 3) Close up of breeding pond shown in Fig. 2
This stagnant area, only 5-10 cm deep, is too shallow to support fish and at time of photograph, did support a large population of mosquito larvae and pupae. (Rowley, Mass. 28 June 1978)

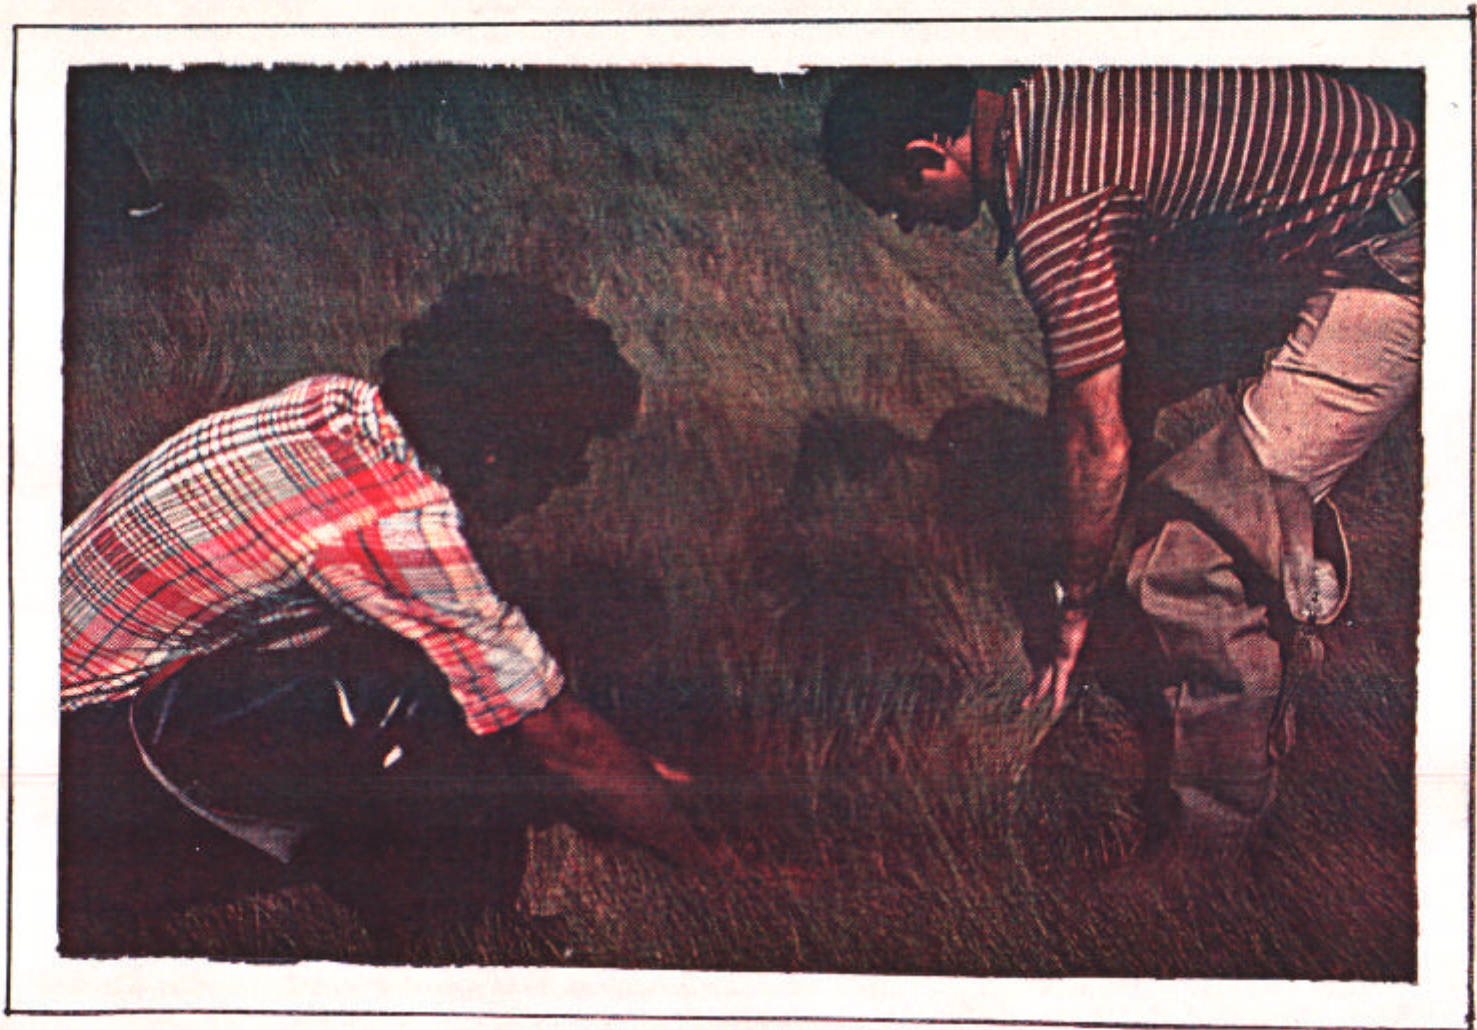
(Fig. 4) Pockets of stagnant surface existing under a blanket of grass can often provide suitable breeding habitat for mosquitos. (Fairhaven, Mass. 18 August 1978).

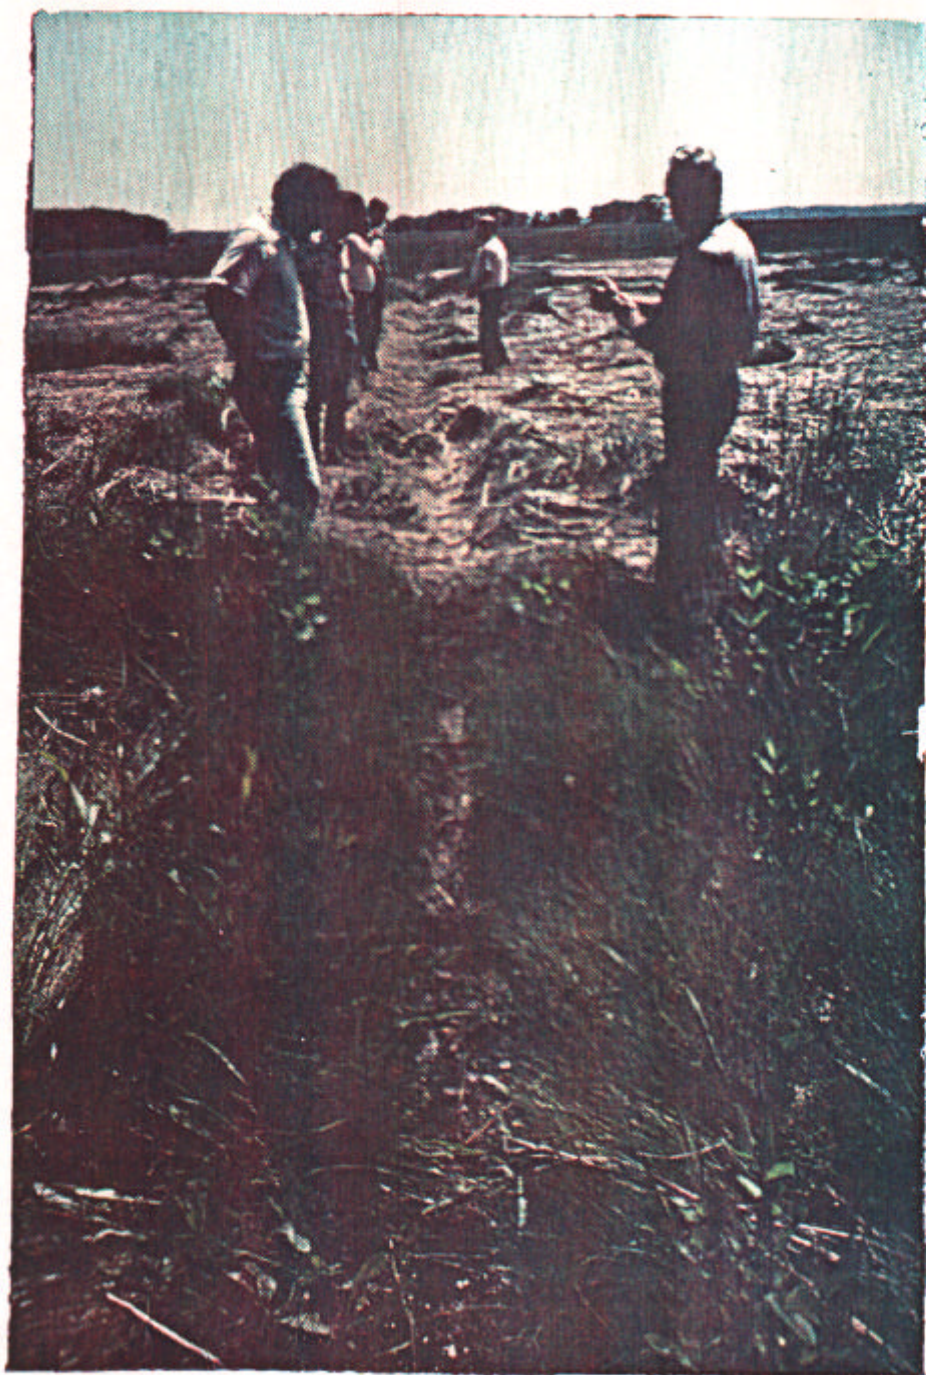
(Fig. 5) Mosquito ditch clogged with dead plant debris which will be cleared by hand. (Rowley, Mass. 28 June 1978).

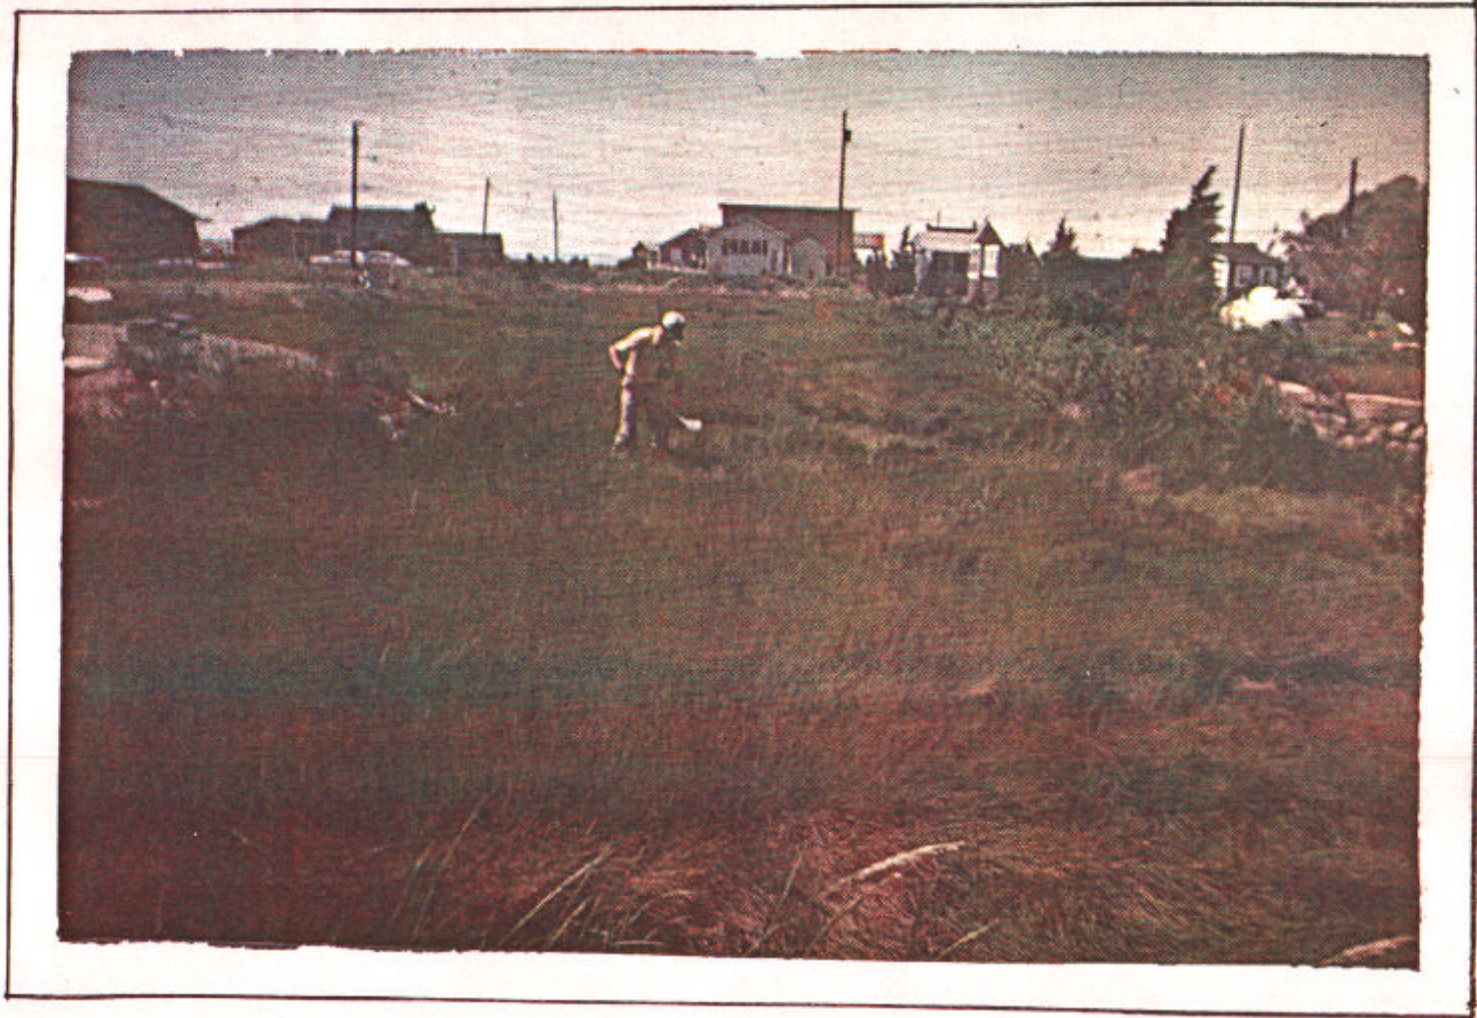
(Fig. 7) The standard technique for sampling mosquito larvae involves counting the larvae scooped from a potential breeding area in a 2 ml. cup. (Mattapoisett, Mass. 14 August 1978).

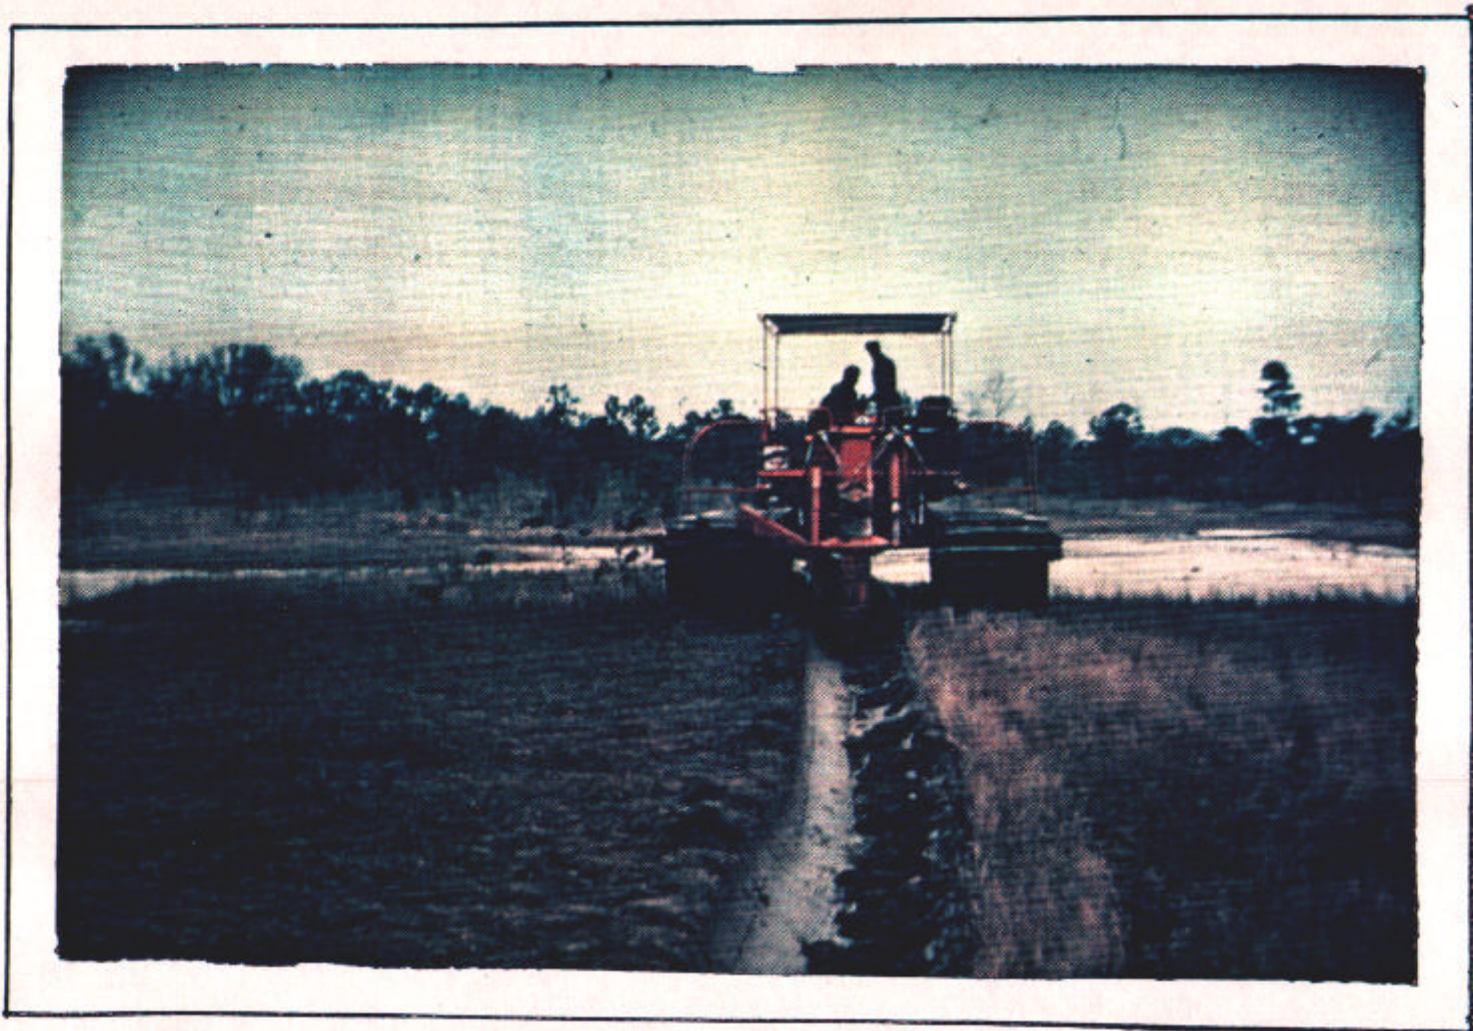
(Fig. 8) Rotary Ditching machine spreading spoil
as it cuts ditch. (New Jersey).

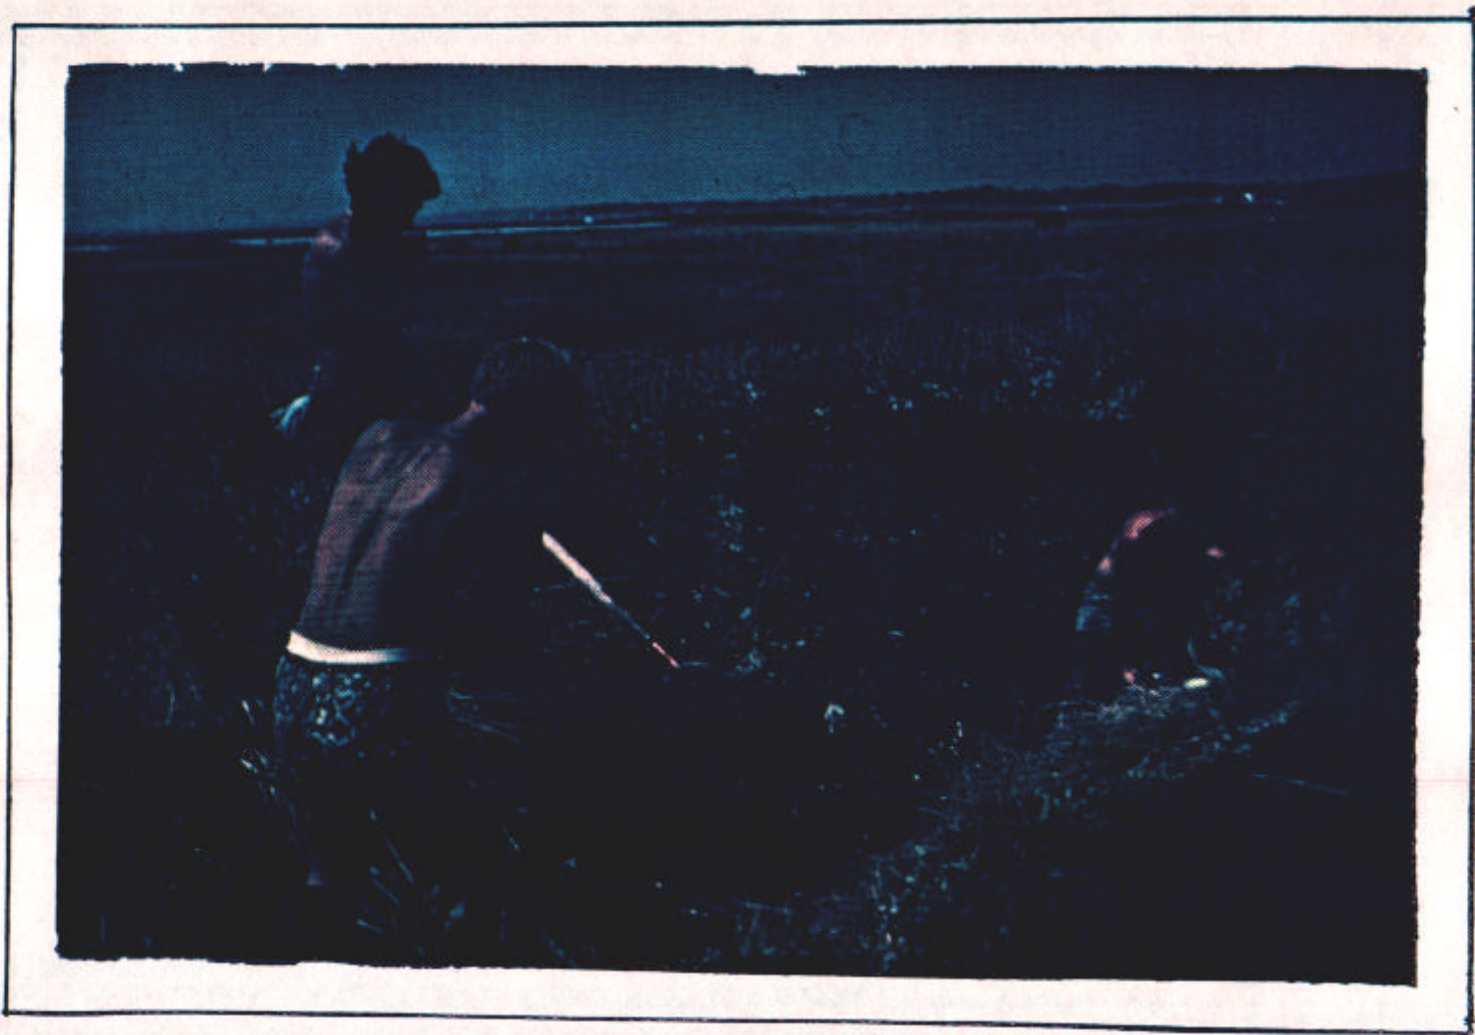
(Fig. 9) Ditching by hand in a saltmarsh.
(Barrington, RI. 19 July 1978).

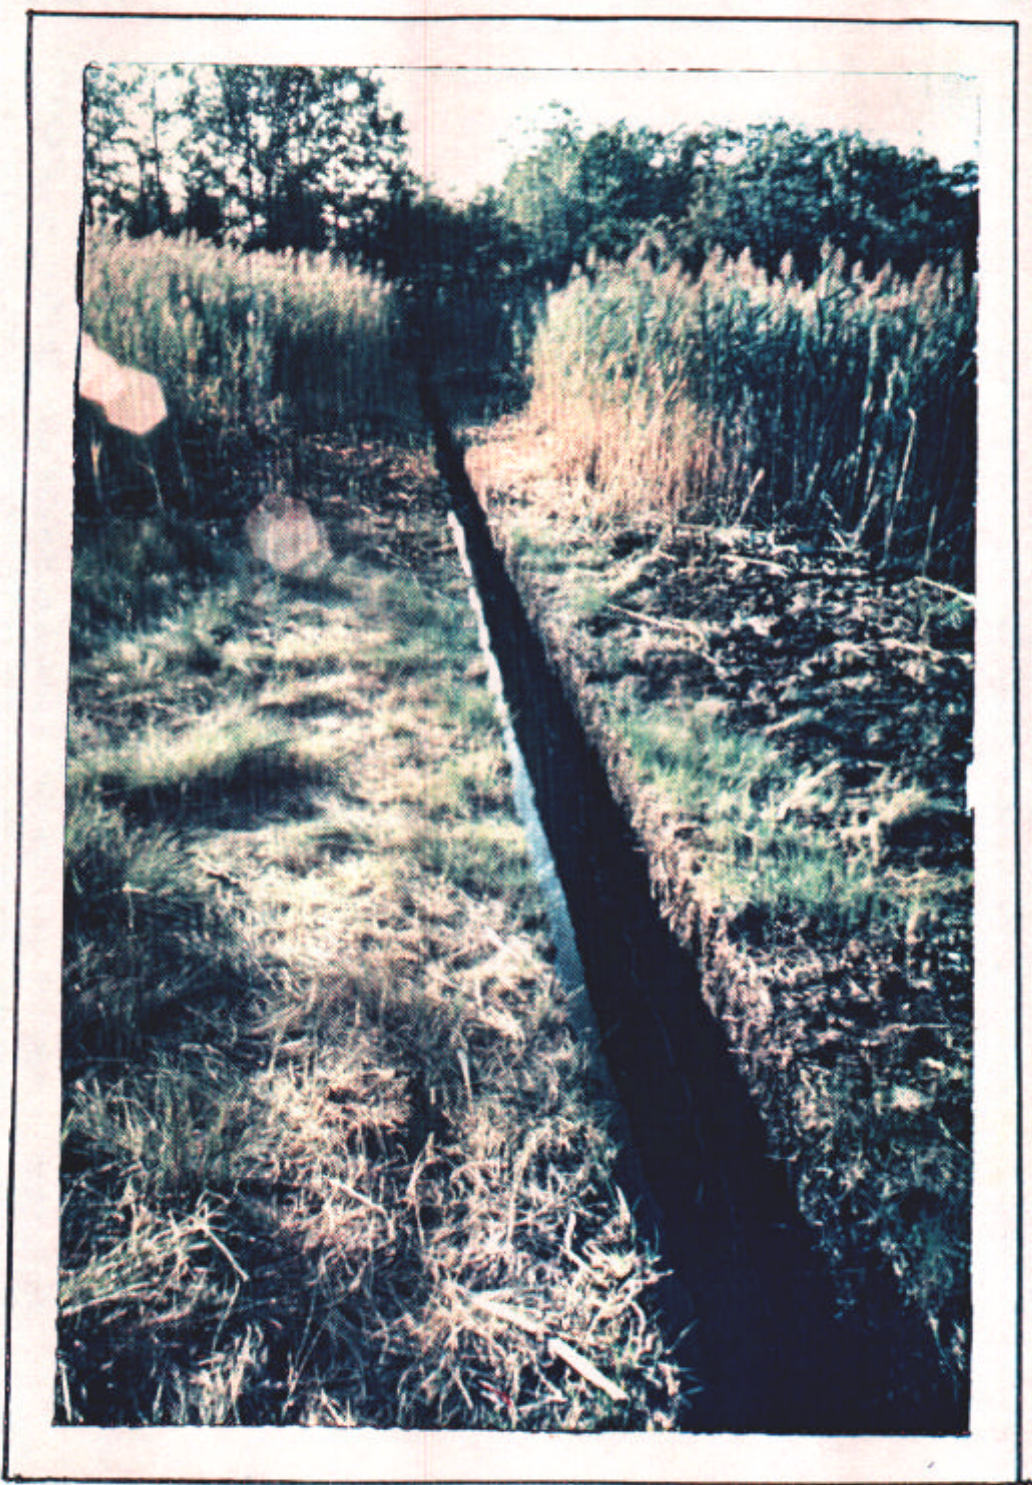
(Fig. 10) Ditch recently cleared by hand. (Bar-
ington, RI 9 September 1977).

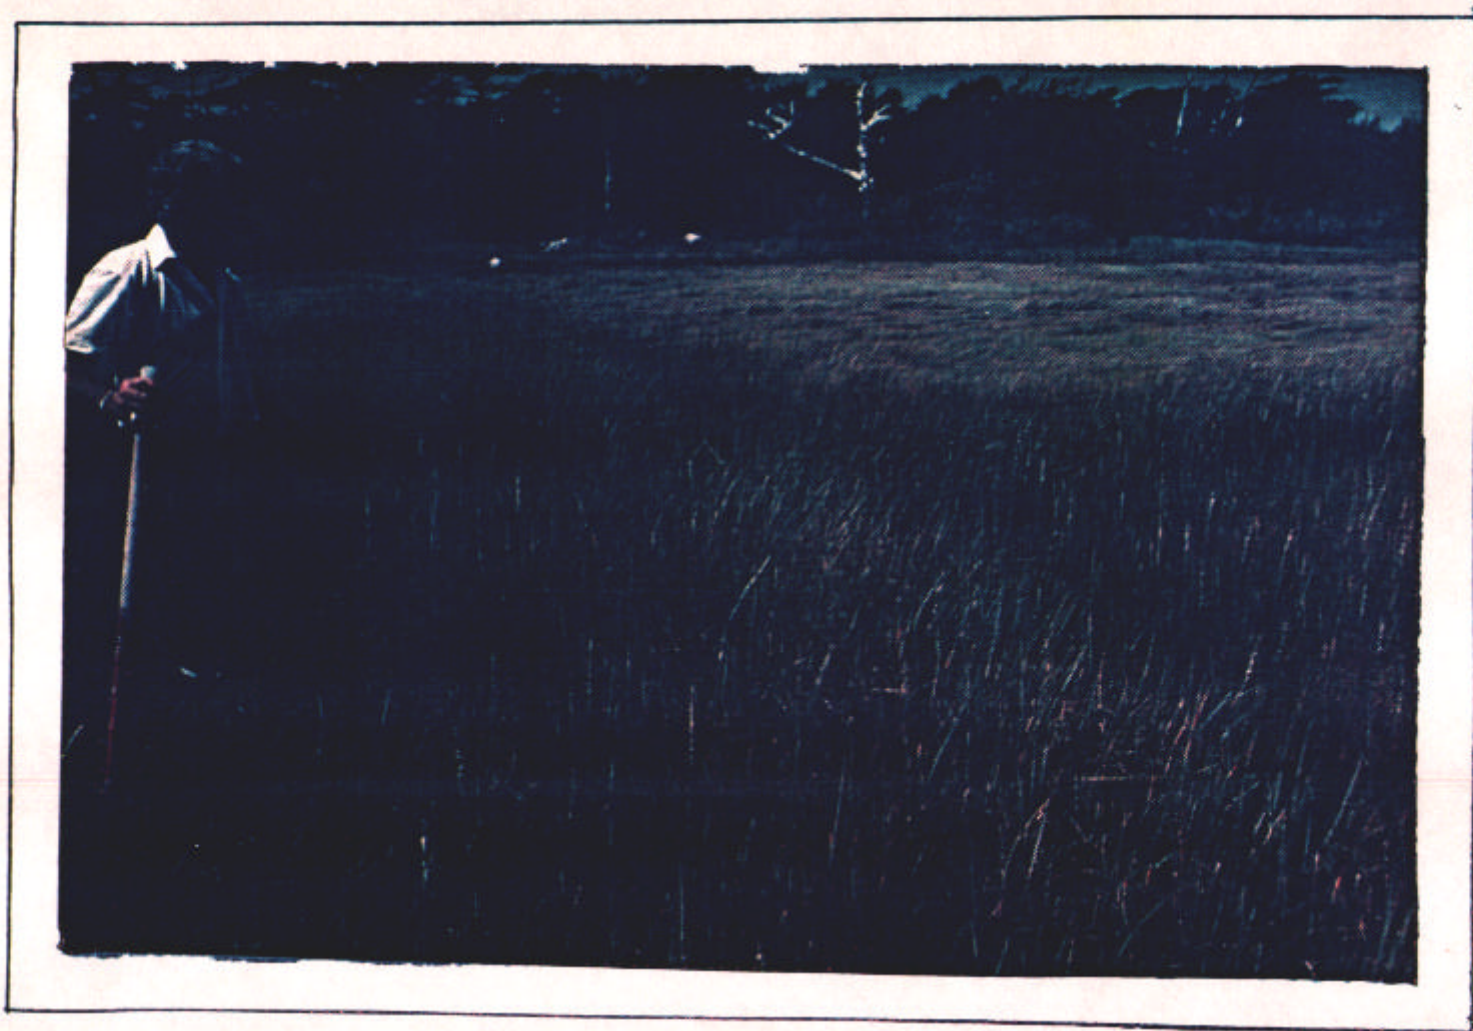
Use of machinery is much more efficient, particularly when the ditches have accumulated heavy deposits of silt or dense growths of sod (Figure 11). Clamshells and backhoes were the machines most commonly

(Fig. 11) An old mosquito ditch which has become overgrown with saltwater cordgrass (sparting alterniflora). Stagnant conditions which breed mosquitos have been created here and the ditch must be cleared to eliminate them. (Fairhaven, Mass. 18 August 1978).

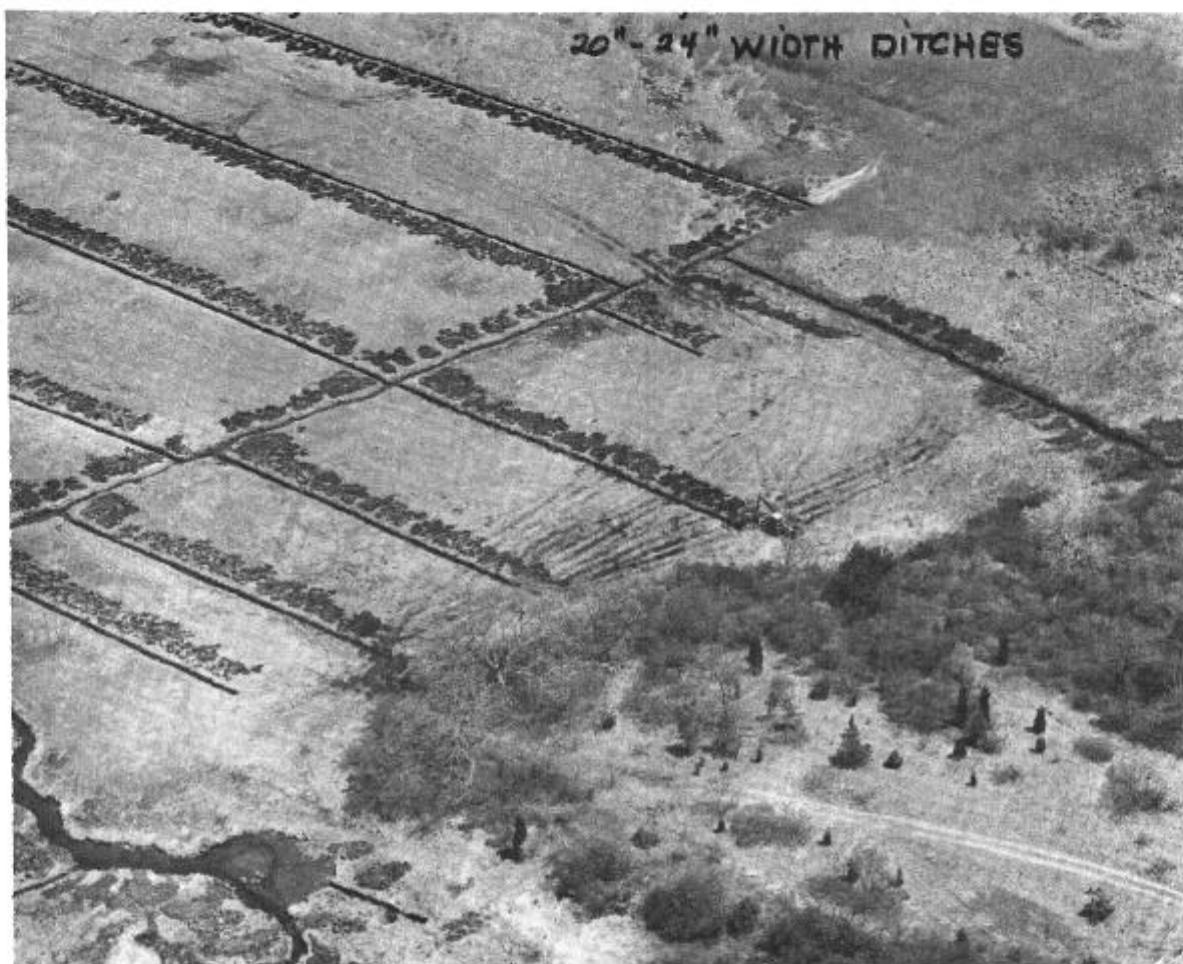
(Figure 12) Backhoe at work in Great Marsh
on Cape Cod. (Barnstable, Mass. May 1974).

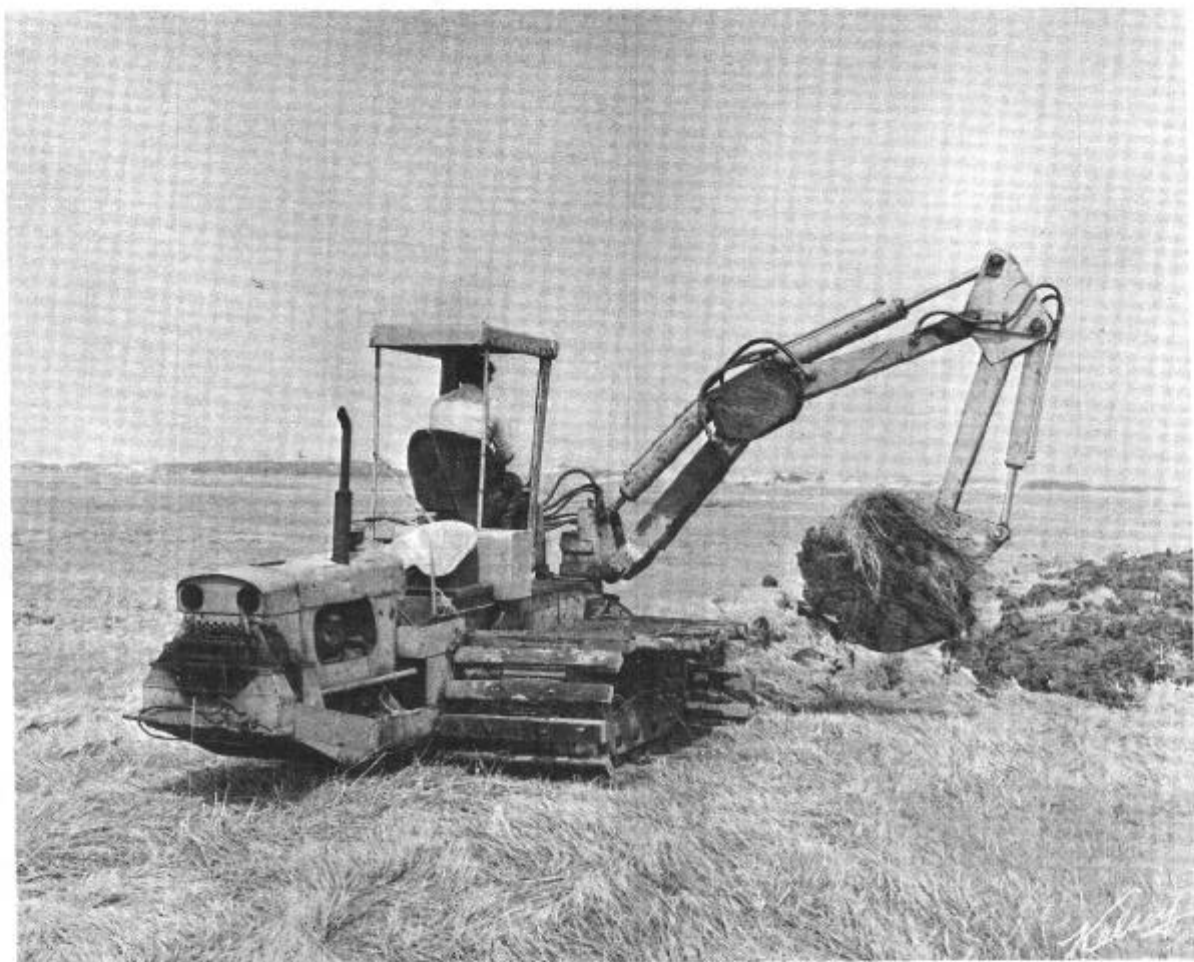
(Figure 13) Backhoe with wooden planks on tread on Cape Cod Saltmarsh.

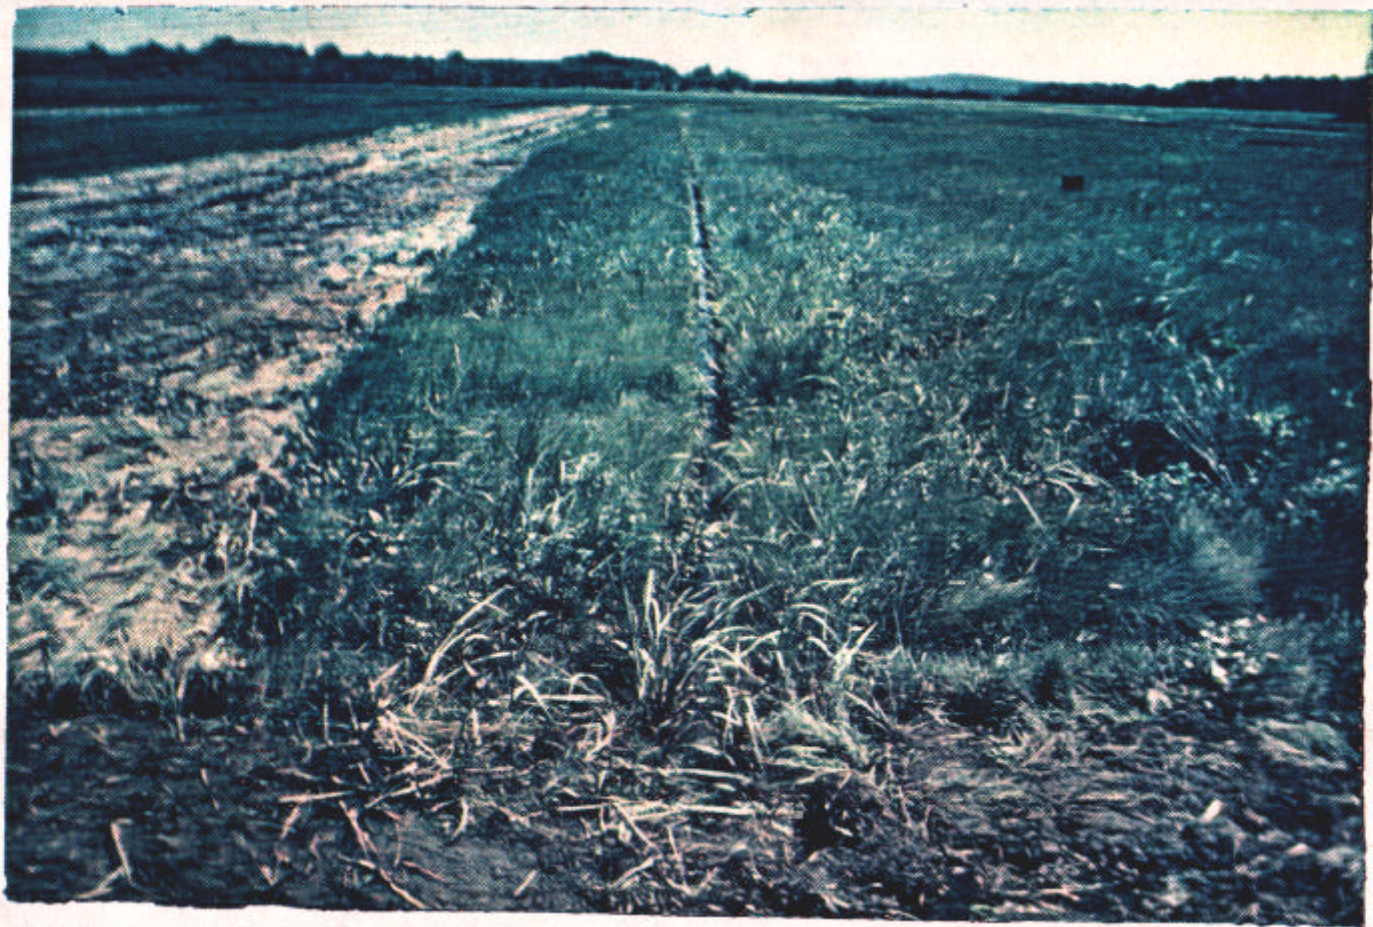
Immediately after clearing, spoil scattered on the marsh was visually unattractive. However, after short recovery periods, it was difficult to tell that work had taken place (Figure 14). Physical evidence of disturbance in the

(Fig. 14) Ditch and spoil resulting from maintenance 1 week earlier on right. Ditch maintained in same manner 1 year earlier on right. (Newbury, Mass 28 June 1978).

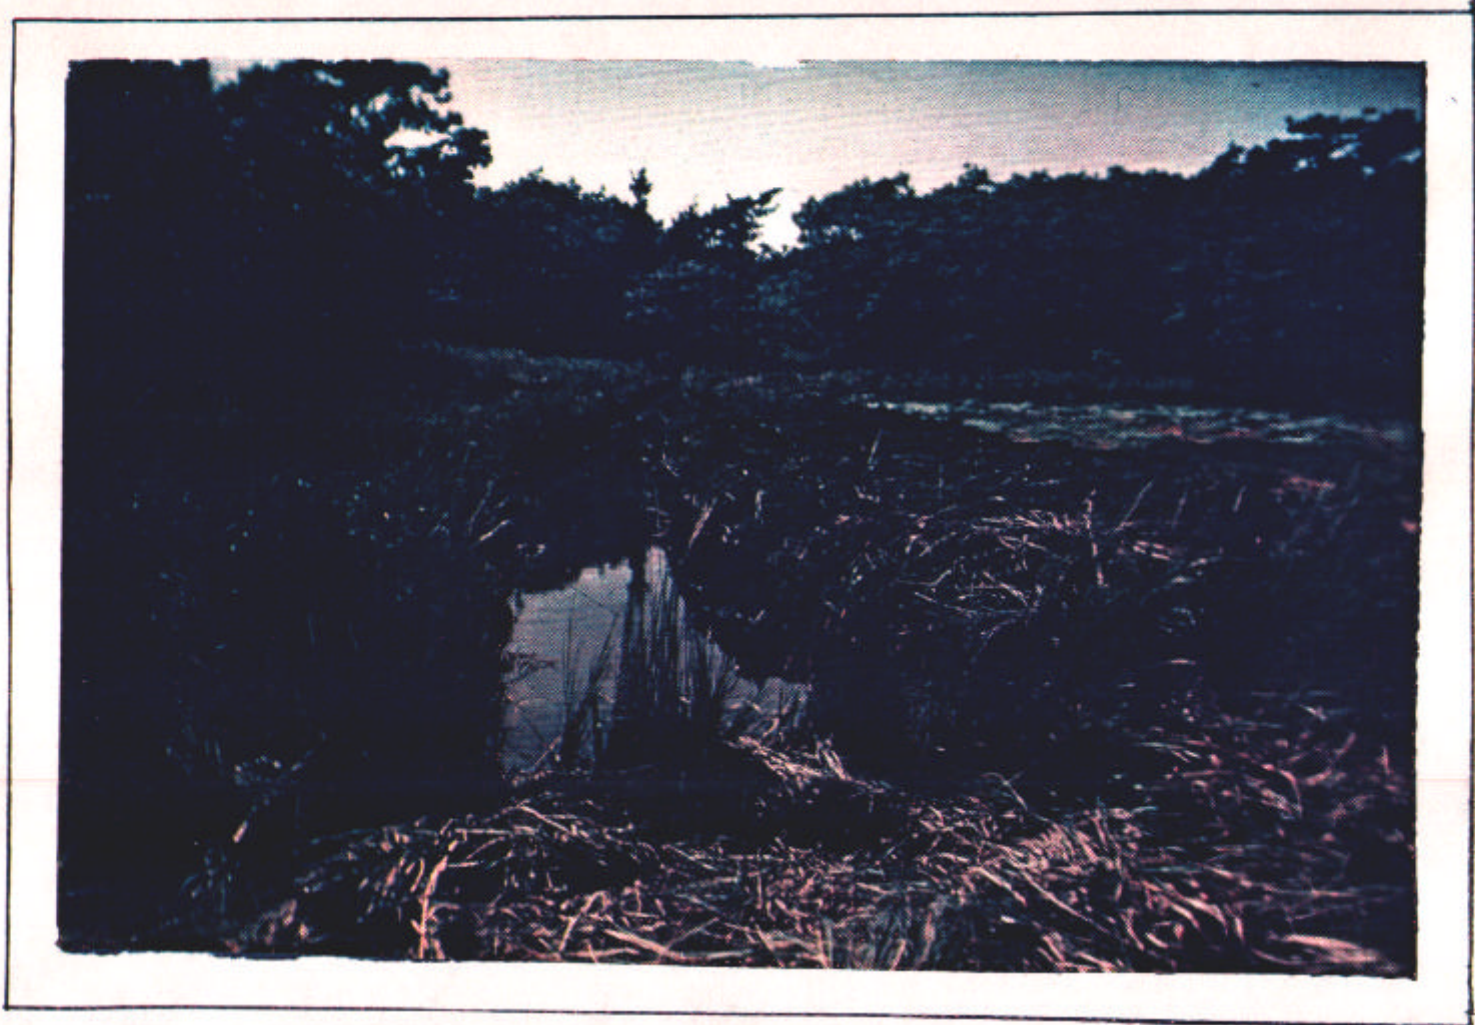
The worst case of spoil deposition was observed in Plymouth County, Massachusetts. Figure 15 shows this area which had been worked by a backhoe approximately 7 days earlier leaving spoil approximately 30 cm or more deep. Representatives of both the Plymouth Country Mosquito Control Project and the Massachusetts Cooperative Extension Service who were present during the field visit expressed the observation that within one to two years the soil is winnowed out of such a deposit by rain and tides leaving only peat and undecomposed root structures, and that the saltmarsh has re-established itself on the site. It is interesting to note that at a different site in Bristol County, we found a spoil deposit several years earlier by a backhoe which, possibly due to a much sandier composition, was still over 30 cm. high but completely enveloped by saltmarsh grasses, primarily salt meadow grass, *S. patens* (Figure 16).

(Fig. 15) Spoil deposited on saltmarsh by recent backhoe work. Layer of spoil to right was approximately 30 cm thick. (Wareham, Mass. 14 August 1978).

6. Monitor the deposits with the greatest depth and least spreading of spoil (e.g., the Plymouth County site in Figure 15) to determine the long term effect and, subsequently, the desirability of this technique.

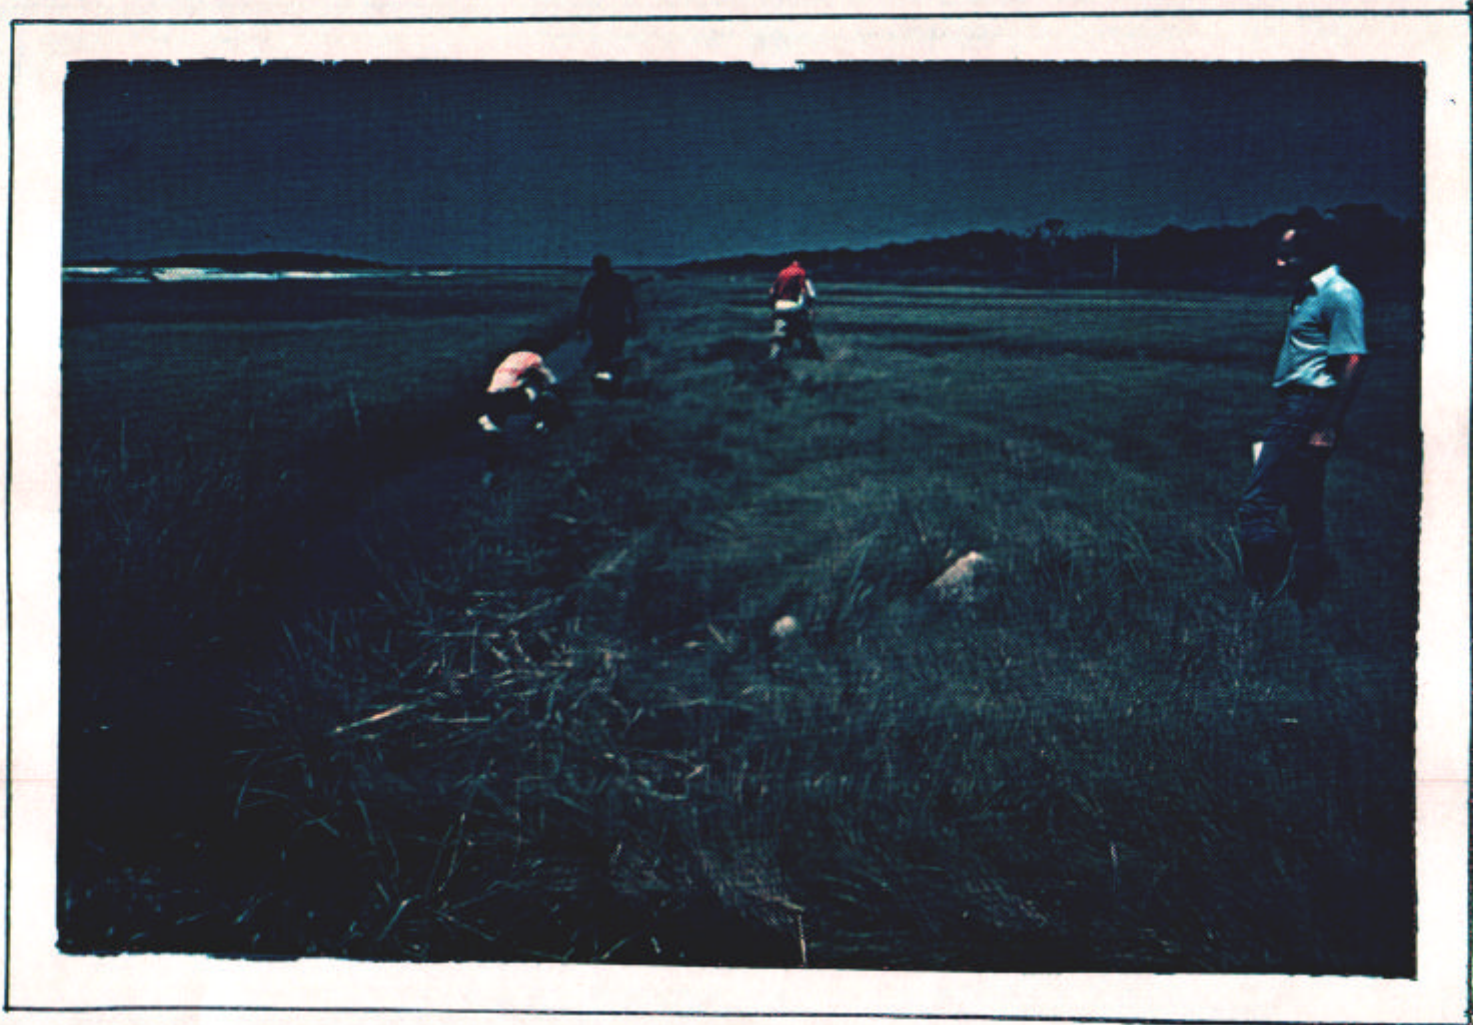
(Fig. 16) Spoil pile (left of ditch) deposited several years earlier by a backhoe clearing the ditch. Although pile is over 30 cm high in some places, it has been totally reolonized by marsh plants, primarily grass species such as salt meadow grass, Spartina patens. (Fairhaven, Mass. 18 August 1978).

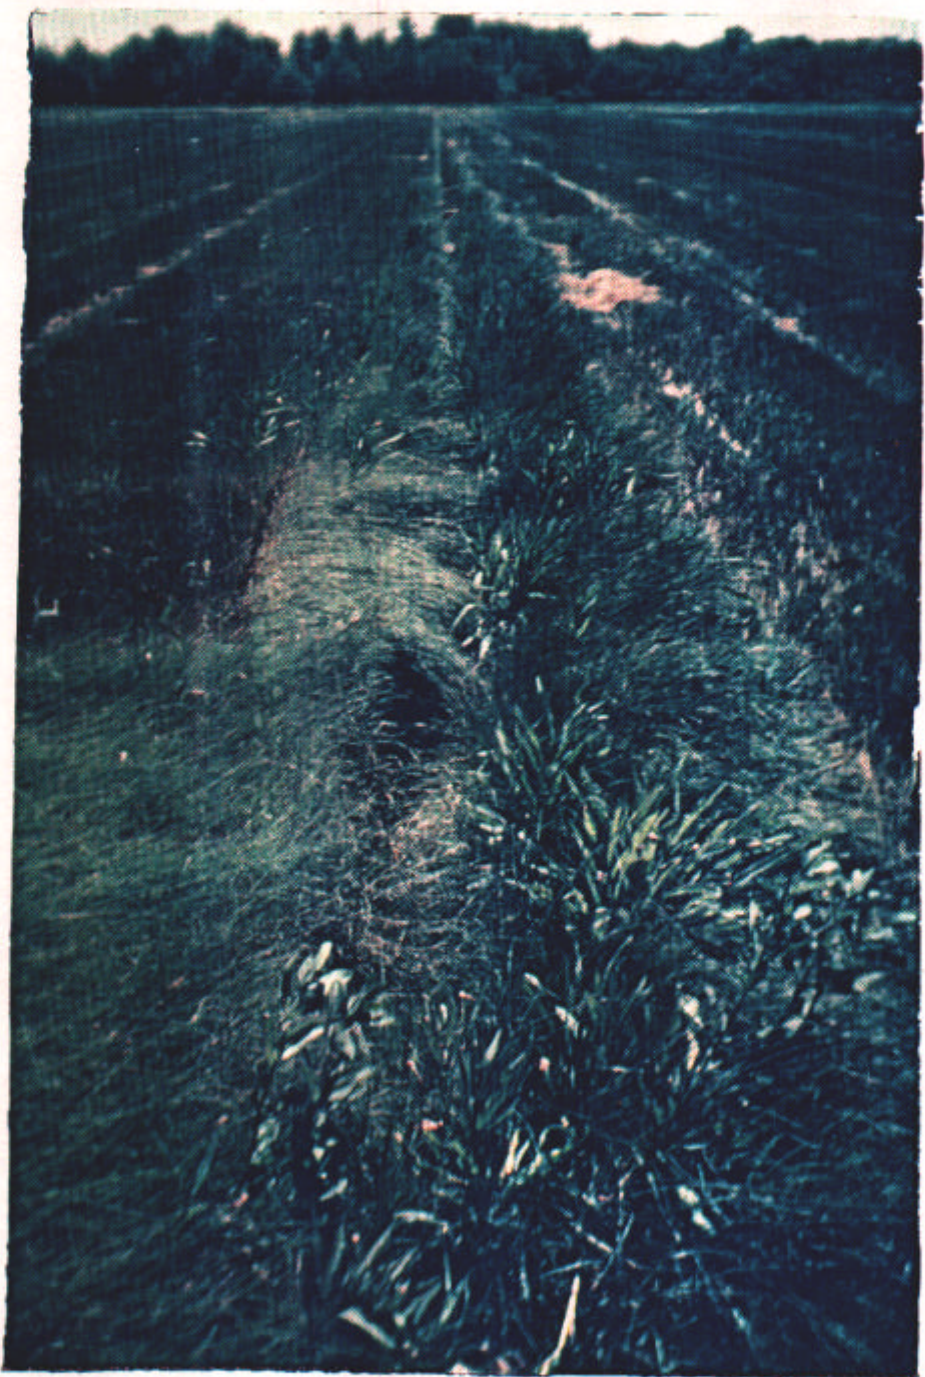
(Fig. 17) Ten years after this ditch was cleared by scavel plow, there is no visible evidence of the bead of spoil. This bead was 4--8 cm in height and ran parallel to the ditch several feet away on either side of it. The wetland including the spoil bead is dominated by salt meadow grass (Spartina patens) which has been moved recently for salt hay. (Newbury, Mass. 28 June 1978).
